GENESEE RIVER BASIN

HEMLOCK LAKE DAM

LIVINGSTON COUNTY, NEW YORK
INVENTORY No. NY 477

PHASE I INSPECTION REPORT NATIONAL DAM SAFETY PROGRAM

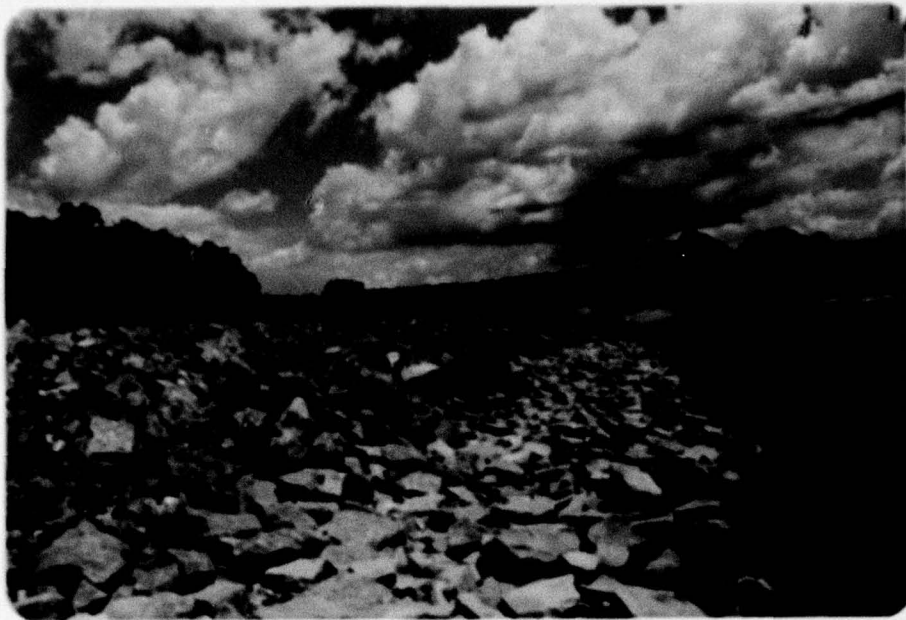
Most of the embankment was grass covered and in good condition. However, visual inspection revealed several minor deficiencies. The most serious of these deficiencies was failure of the riprap on the upstream slope of the embankment, west of the spillway. Several areas on the riprap had been scoured and subsided due to wave action. The worst depression was adjacent to the spillway channel where the slope paving had dropped by as much as 2 feet. The slope had been partially regraded with additional riprap. Other deficiencies observed included several trees growing on the downstream slope of the embankment on the eastern end of the structure and small voids between some of the concrete slabs on the upstream face. There were also larger voids on a number of the slabs where one corner had been removed by wave action leaving triangular voids 1 foot long by 1 foot deep.

Riprap on Western End of Dam -
Gray Stone Placed Due to Damage by Wave Action

- a. The damaged portions of the riprap on the upstream face to the west of the spillway should be repaired. In addition, actions should be taken to prevent the scour problem from occurring in the future.
- b. Triangular voids which exist at the corners of many of the concrete slabs on the upstream slope to the east of the spillway should be repaired.
- c. The deteriorated concrete on the spillway and on the retaining walls for the spillway should be repaired.
- d. The trees which are growing on the downstream slope of the eastern end of the dam should be cut.

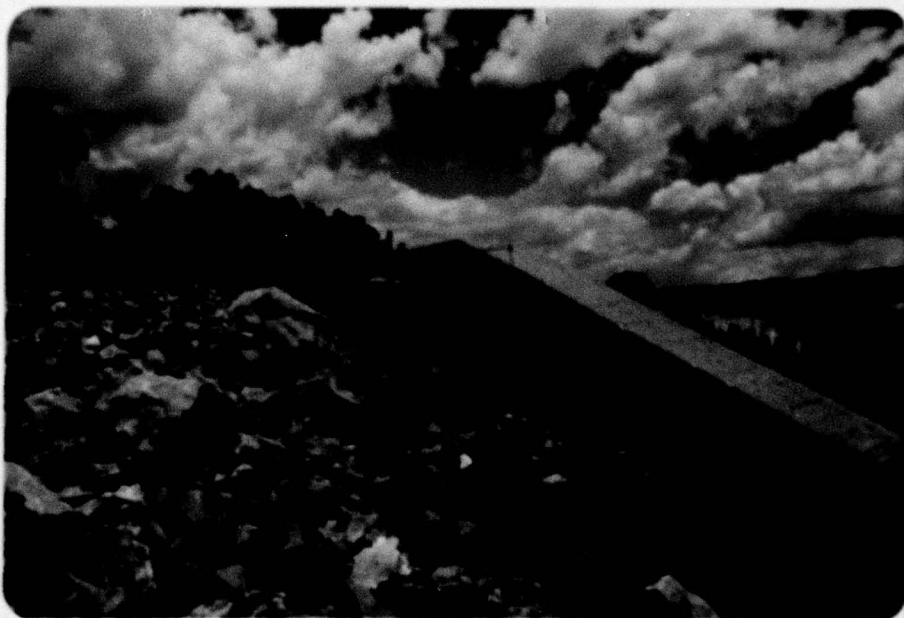
Visual observation of the structure did not reveal any signs of major distress. The upstream slope on the western end of the structure was slightly irregular with depressions which had been caused by wave action.

Depression on West End of Spillway Caused by Wave Action

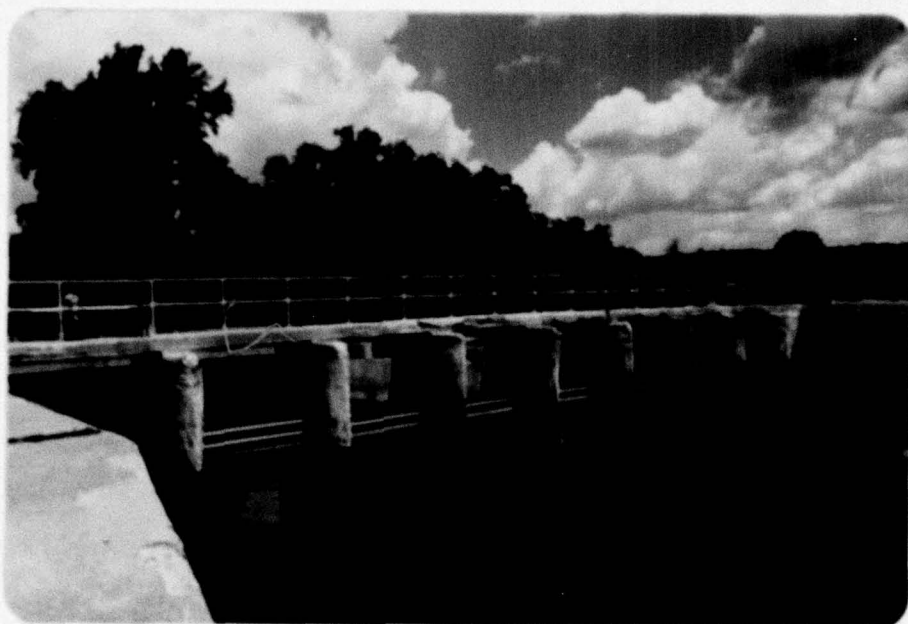
Spillway Section - Channel Stopgates in Place

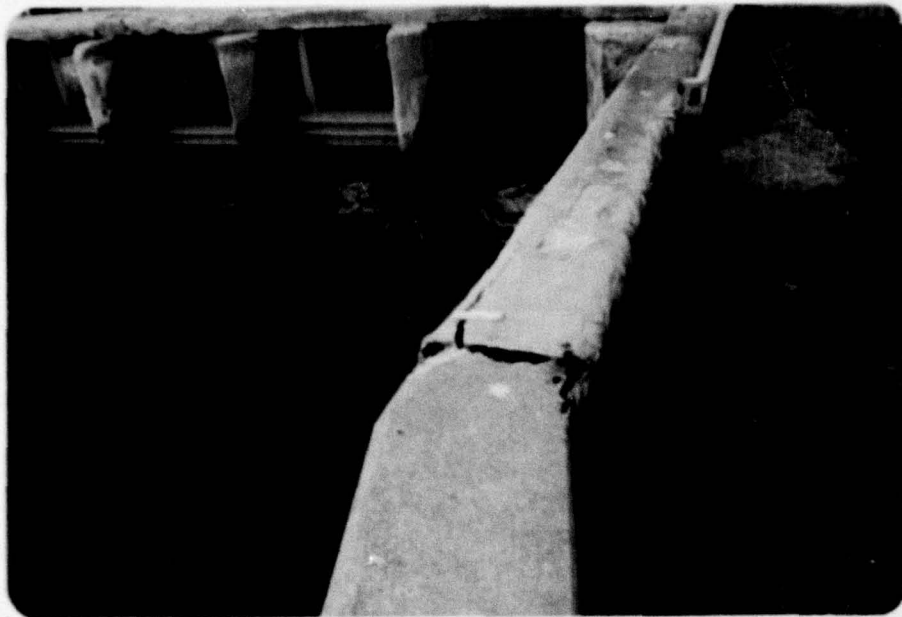
Crack in Patching Material on Wingwall at East End of Spillway

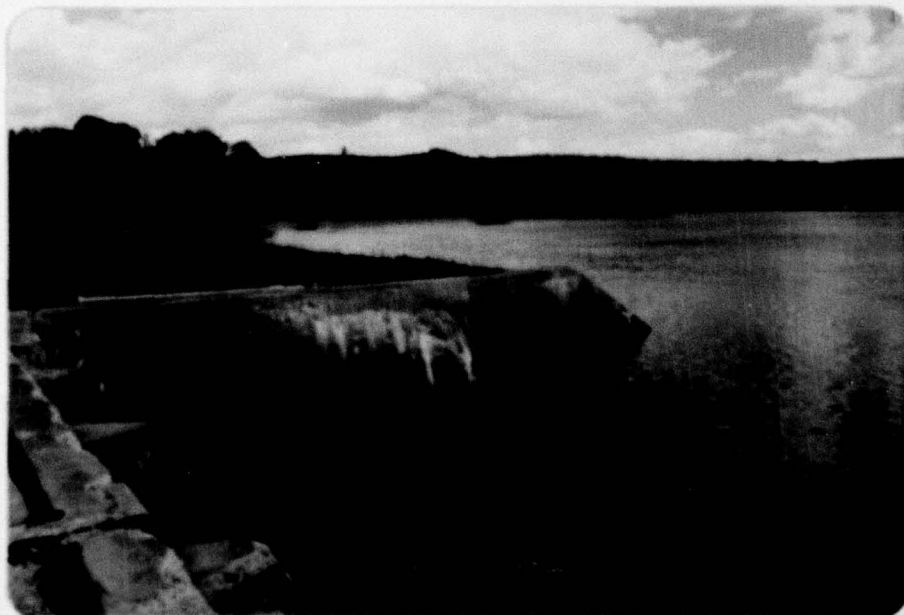
The spillway was generally in satisfactory condition. No deficiencies were noted on the ogee section, the flashboards, or the downstream apron. The concrete on the upstream portion of the structure was somewhat deteriorated and spalling. There was some minor cracking and separation of patching material on the eastern wingwall upstream of the ogee section. There are mechanical hoists in place on two of the eight bays which are used to raise the flashboards. These two devices, which were located above the outermost bay on either end of the spillway, appeared to be operational.

Deterioration of Concrete on Wingwall on East End of Spillway

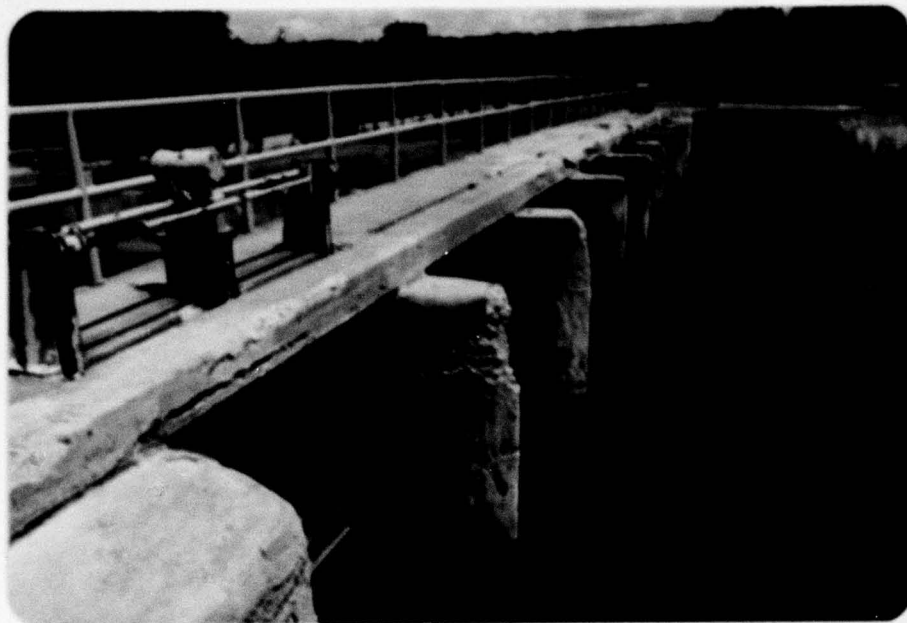
Deteriorated Concrete on Piers and Bridge Deck; also,
Lifting Device Used for Raising Stopgates

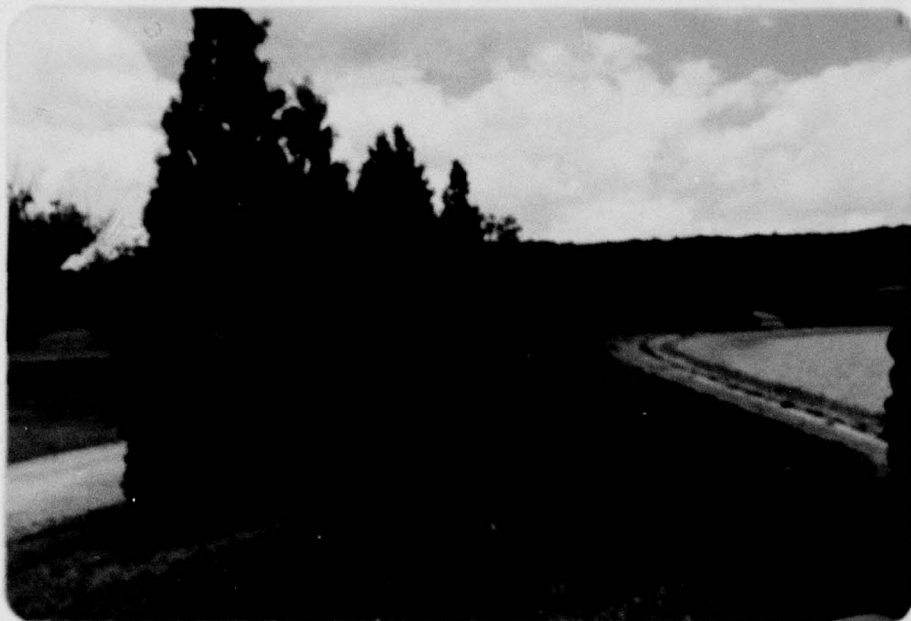
Trees Growing on Downstream Slope at Eastern End of Dam
